Technical BULLETIN

1999~2005 YZF-R6 and 2004~2005 FZ6

Drive Sprocket Retaining Nut and Lock Washer Replacement

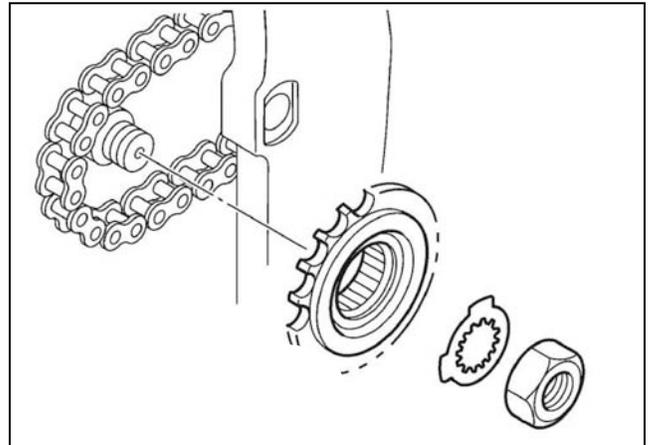
Symptom: In some cases, the drive sprocket retaining nut lock washer can allow the nut to rotate just enough to reduce the clamping force resulting in fretting the drive sprocket retaining nut and lock washer.

Remedy: Replace the drive sprocket retaining nut and lock washer on all units in the affected range regardless of their warranty status.
