Side Stand Switch Fix,

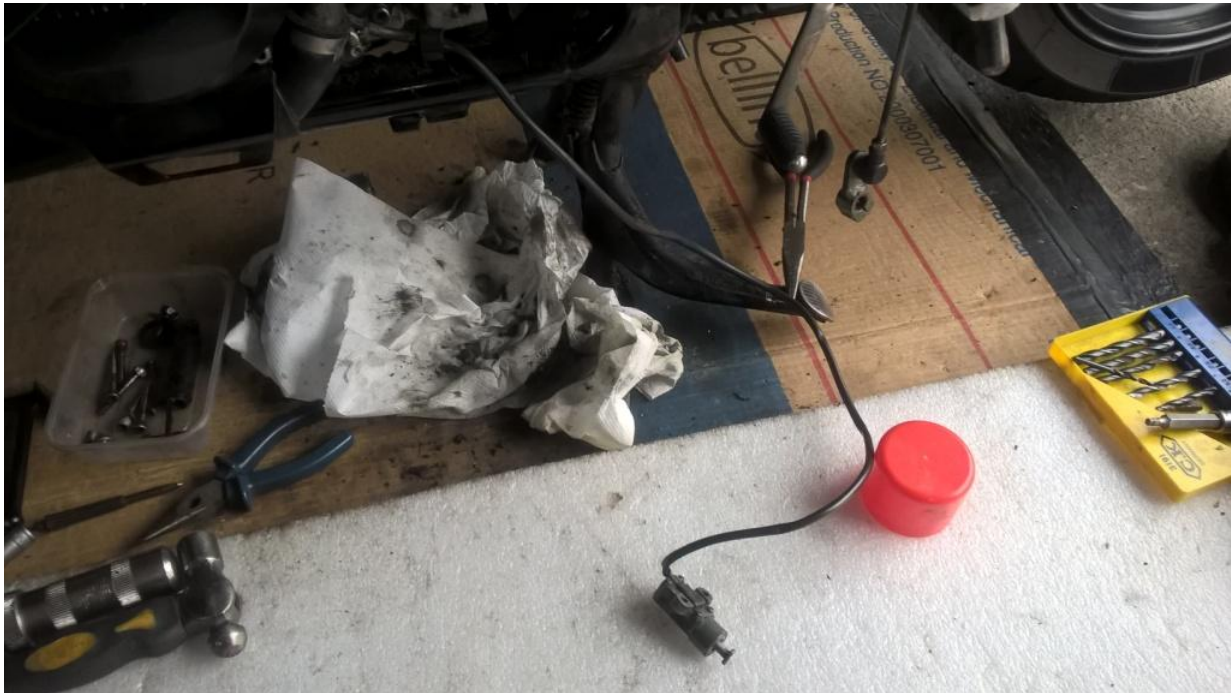
Using a Philips screwdriver open the 4 philips screws

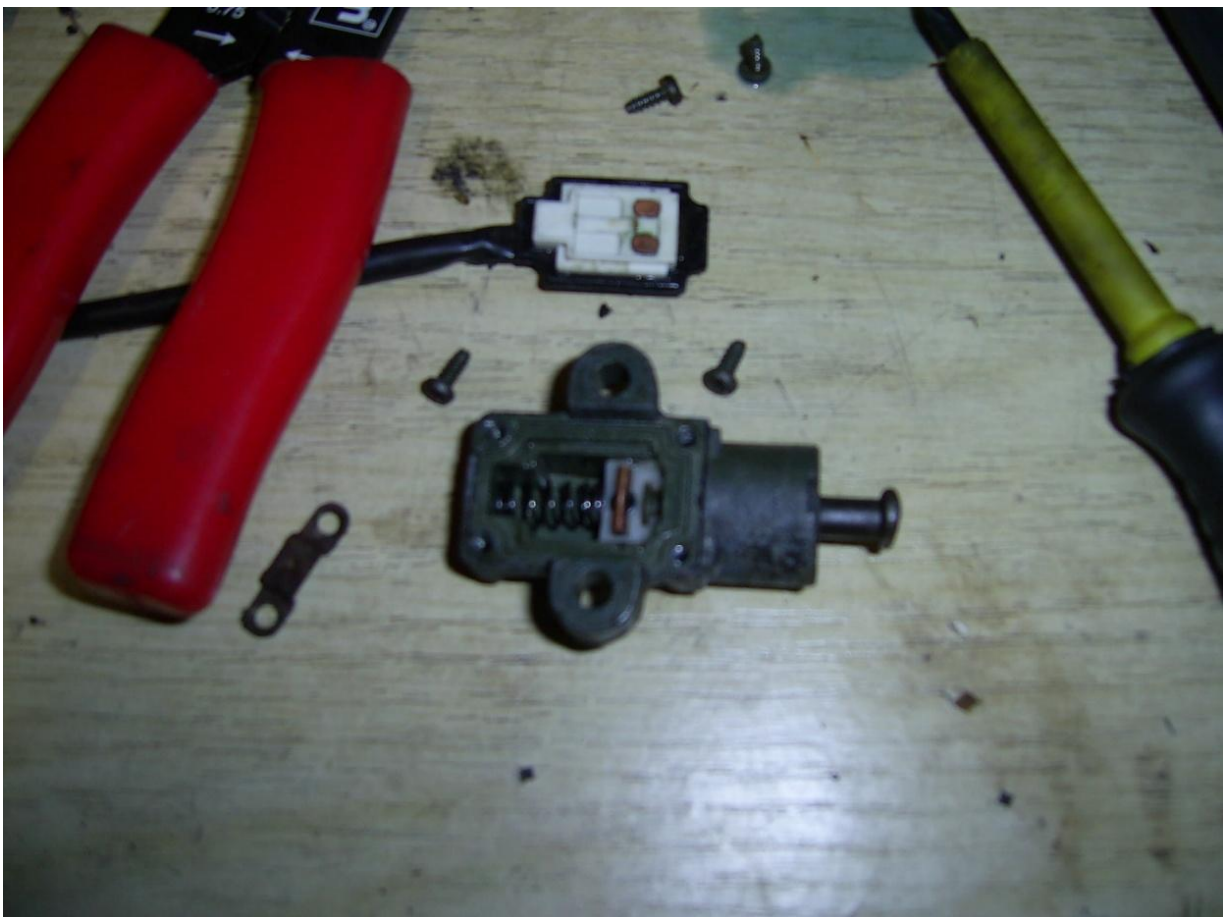
Picture of completely dismantled switch, these were pictures I took when I dismantled a spare switch I have.

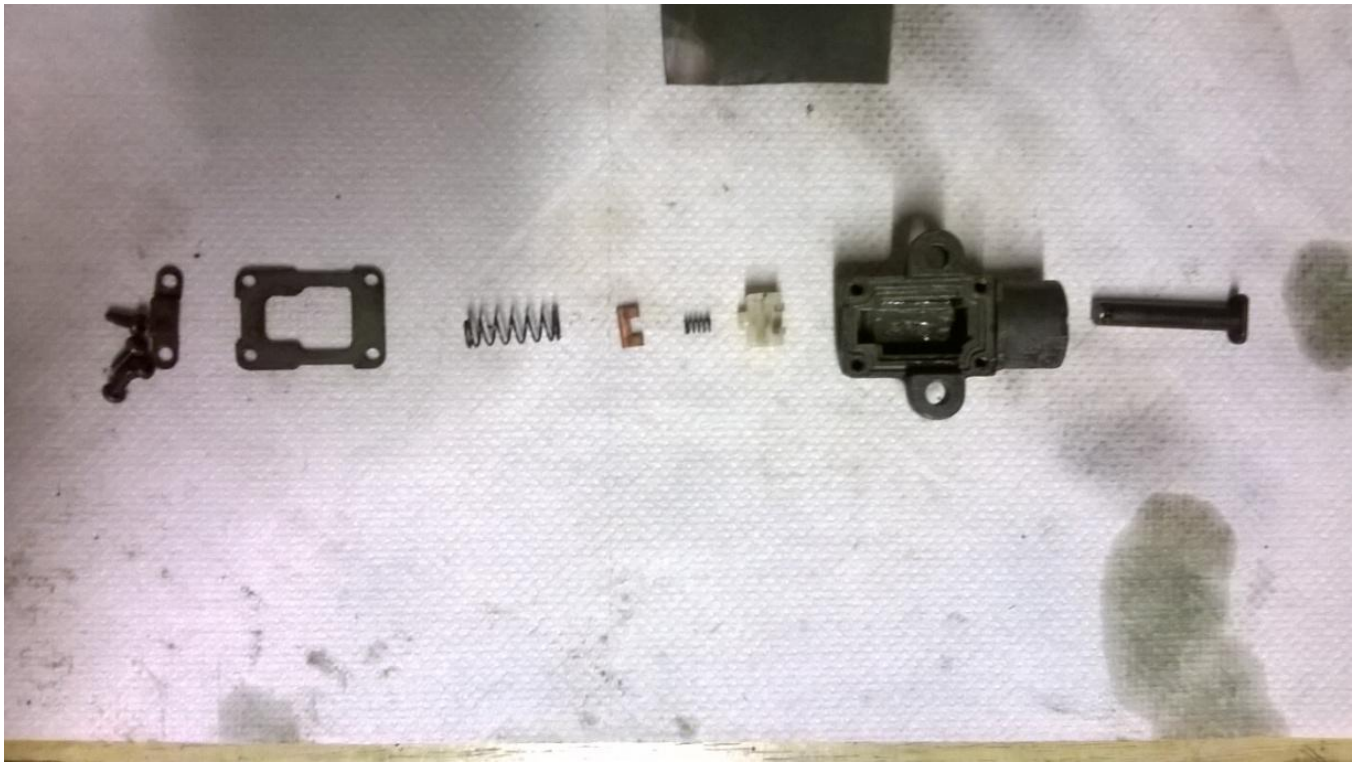
Be careful not to lose the small spring in the sliding part of the switch, I stretched the spring a little as I did not think there was sufficient corrosion on the contacts to cause the open circuit and thought perhaps the spring had settled and was not maintain sufficient pressure on the sliding contact

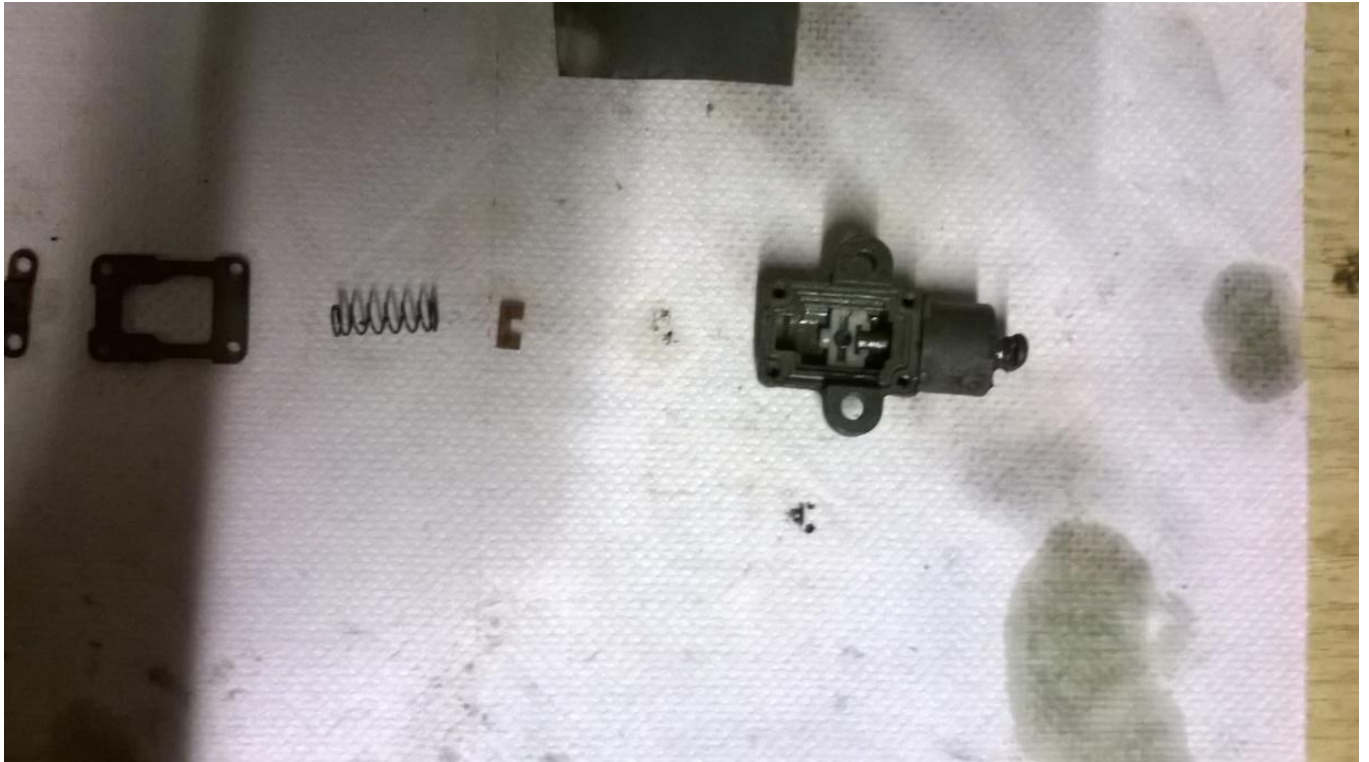
I cleaned the contacts with very fine wet and dry paper also just to be sure.

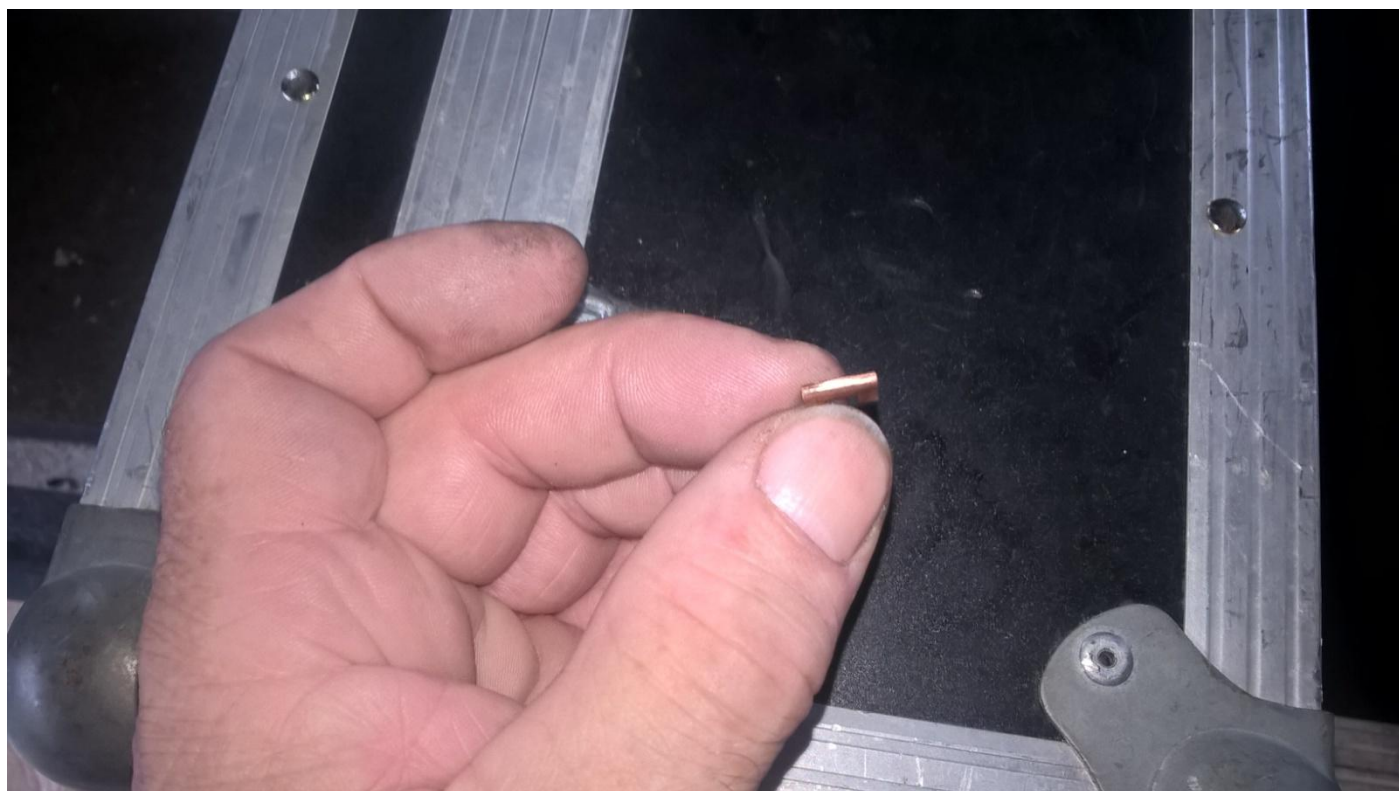
Close up of the removable contact

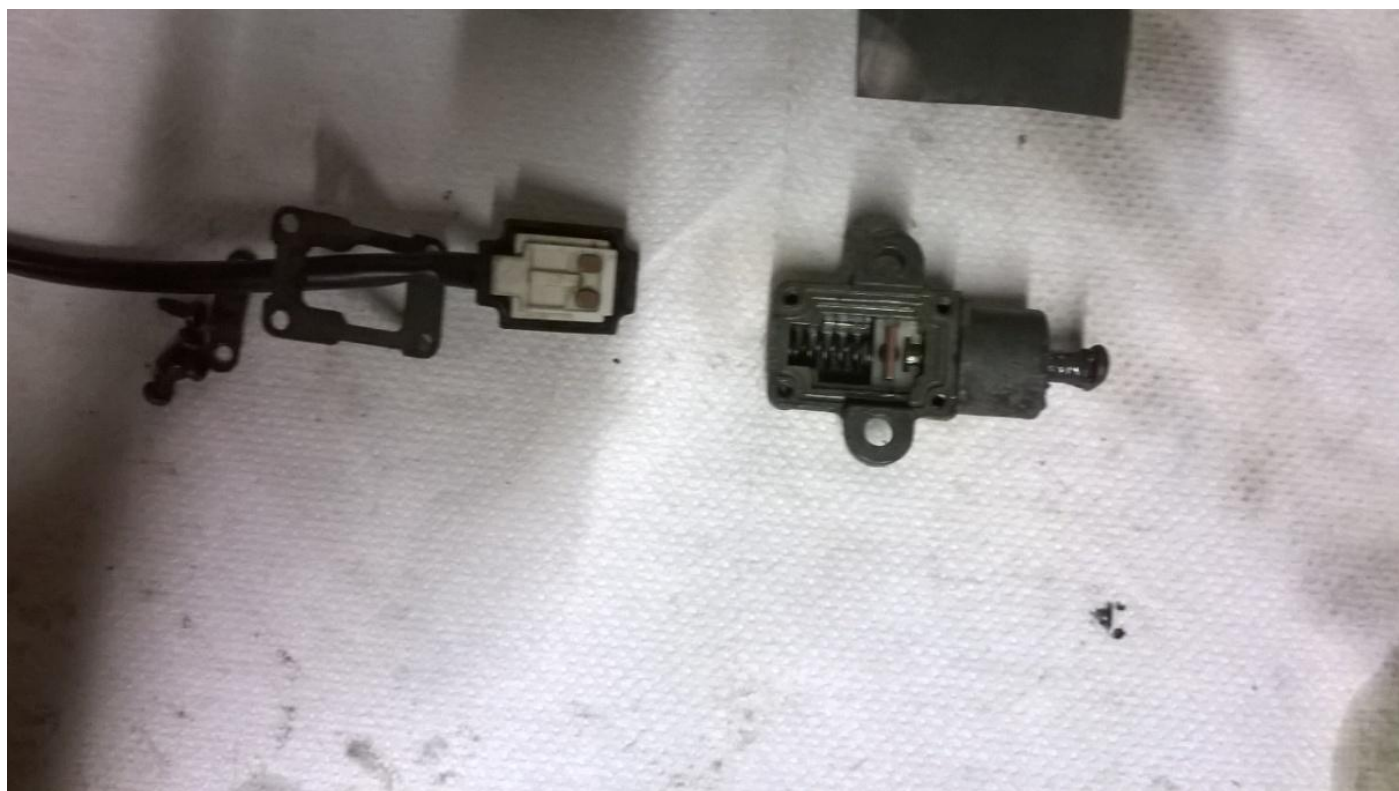
Switch ready for reassembly

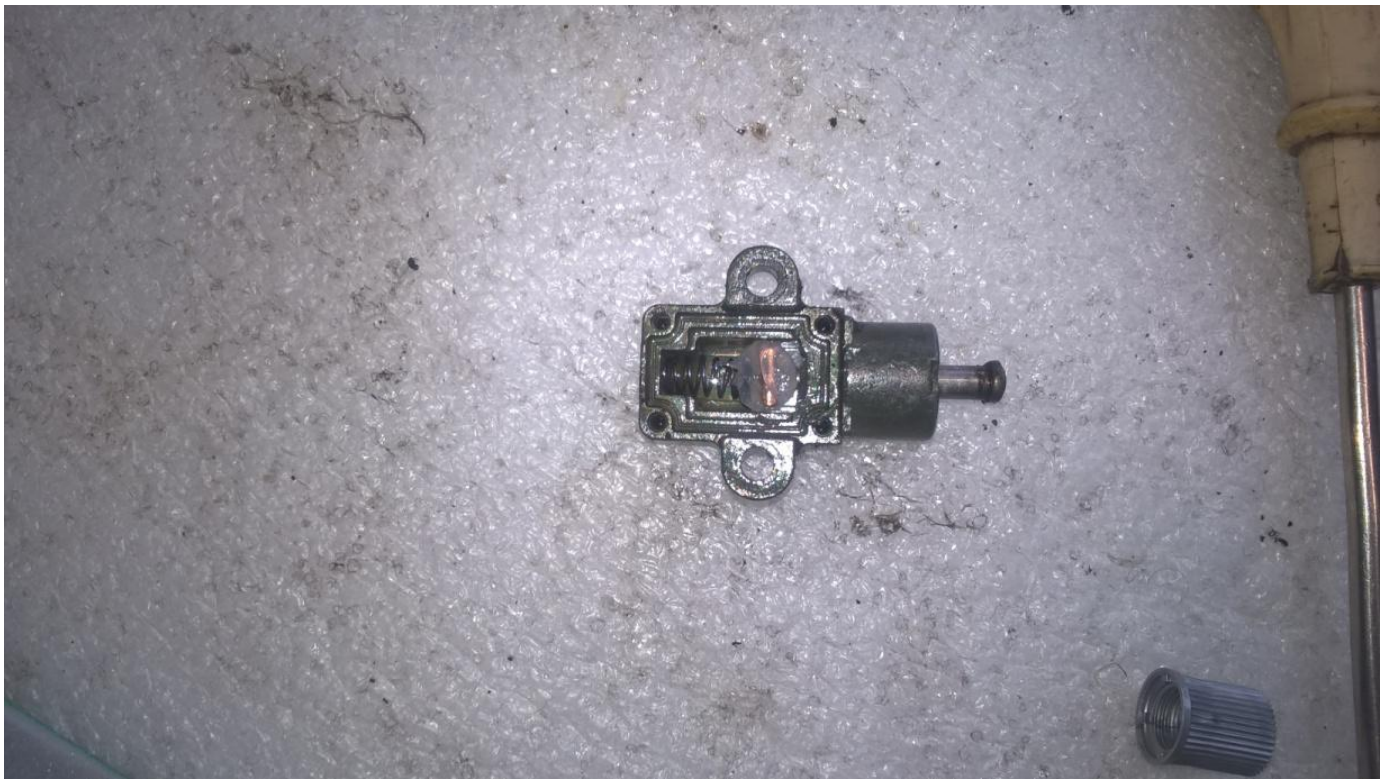
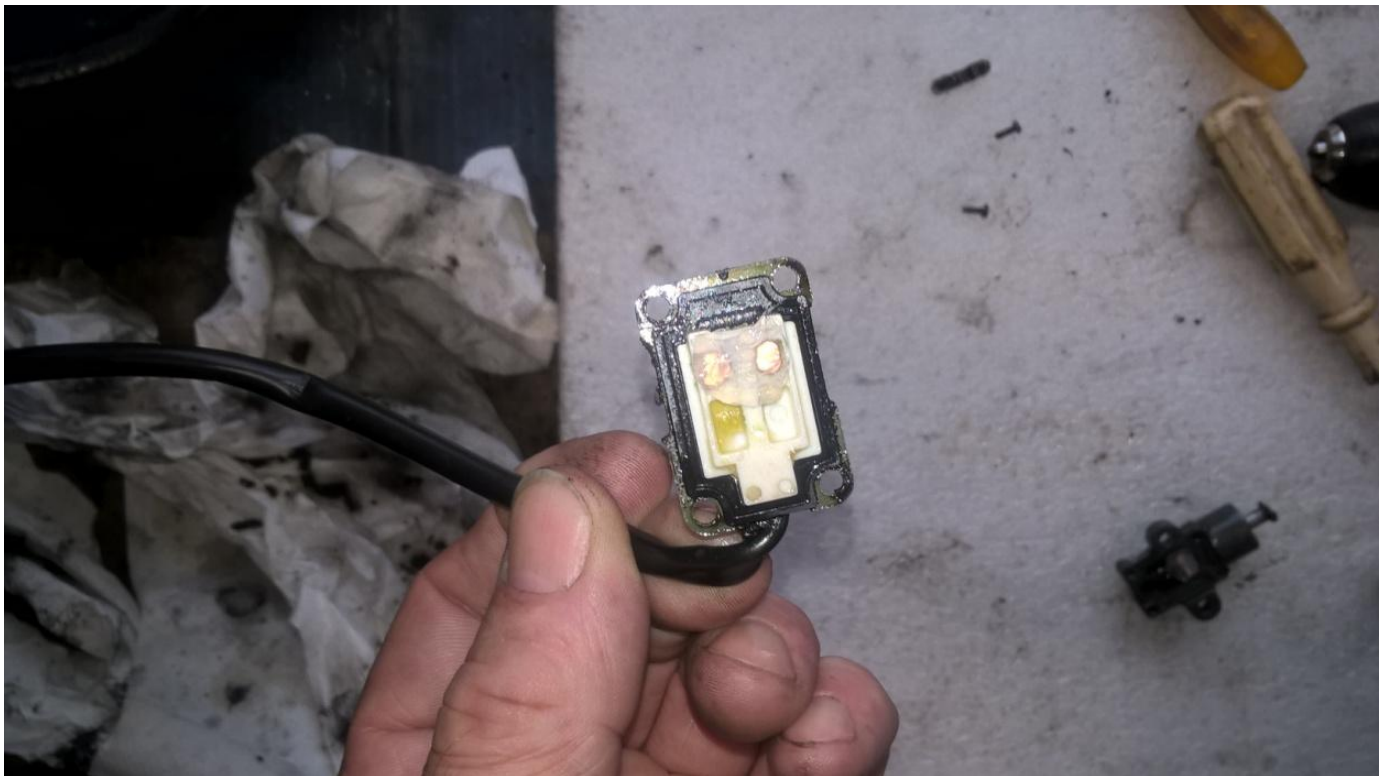
Coat the switch inners and rubber seal with dielectric grease and reassemble it

Operate the plunger a number of times and then test it for continuity with the plunger released. Press in the plunger and continuity should cease.

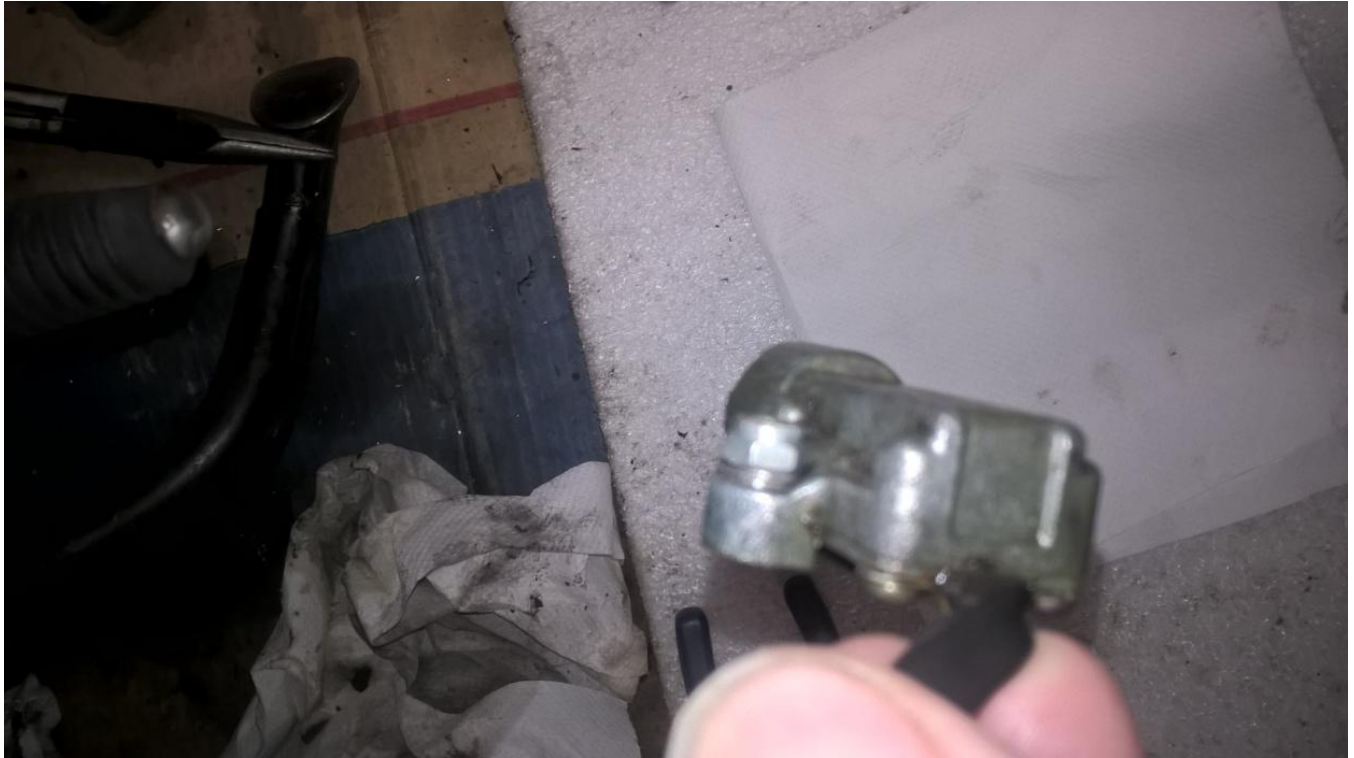
Glue the two washers to each other and then to the Nyloc nut. Now centre the lot on the upper bolt hole of the switch and glue it to the switch. This is required as you cannot put the nut and washers on when the switch is in position. The superglue holds them in place while you start the bolt into the thread of the nut.

See picture below.

The 30mm bolt is too long, but a 25 mm bolt is not long enough to use all the threads of the Nyloc nut. You will have to shorten the bolt by a few mm depending on the thickness of the Nyloc nut. I cut mine down to 27mm. After cleaning up the ends of the threads, the final length was 26mm. Measure the thickness of the 2 washers and Nyloc nut together and add 21mm to it and this is roughly the length the 30mm bolt needs to be cut to and it allows 1 mm to clean the cut to allow the bolt to thread into the nut easily. The full 30mm will make it more difficult to use the spanner later and you may not be able to remove the spanner when the nut and bolt are tightened.

The washers are required to raise the nut off the switch to allow a ring spanner to fit to tighten the Nut and bolt. Put the switch in place and screw on the lower bolt from the underneath, but do not tighten it. Put the longer cut down bolt in from the top and screw it into the glued on nut. Because of the limited space a normal ring spanner will not fit.

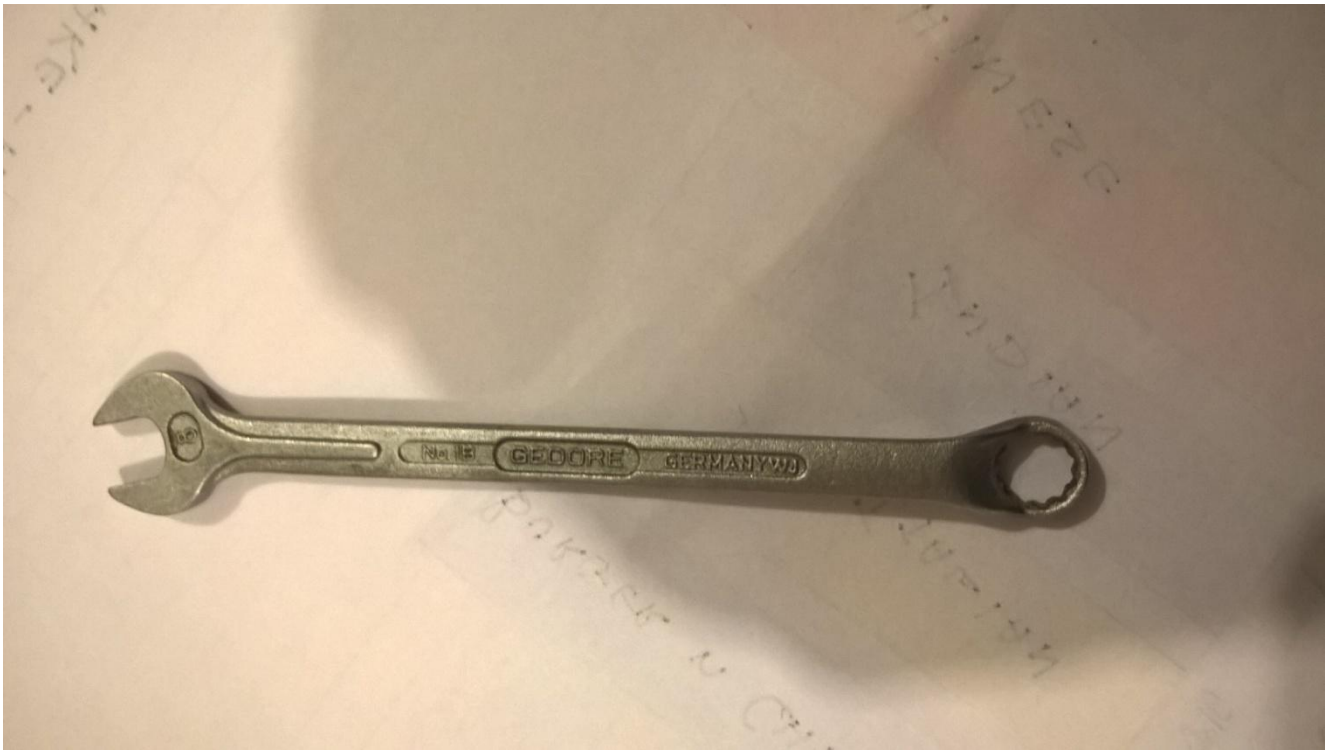
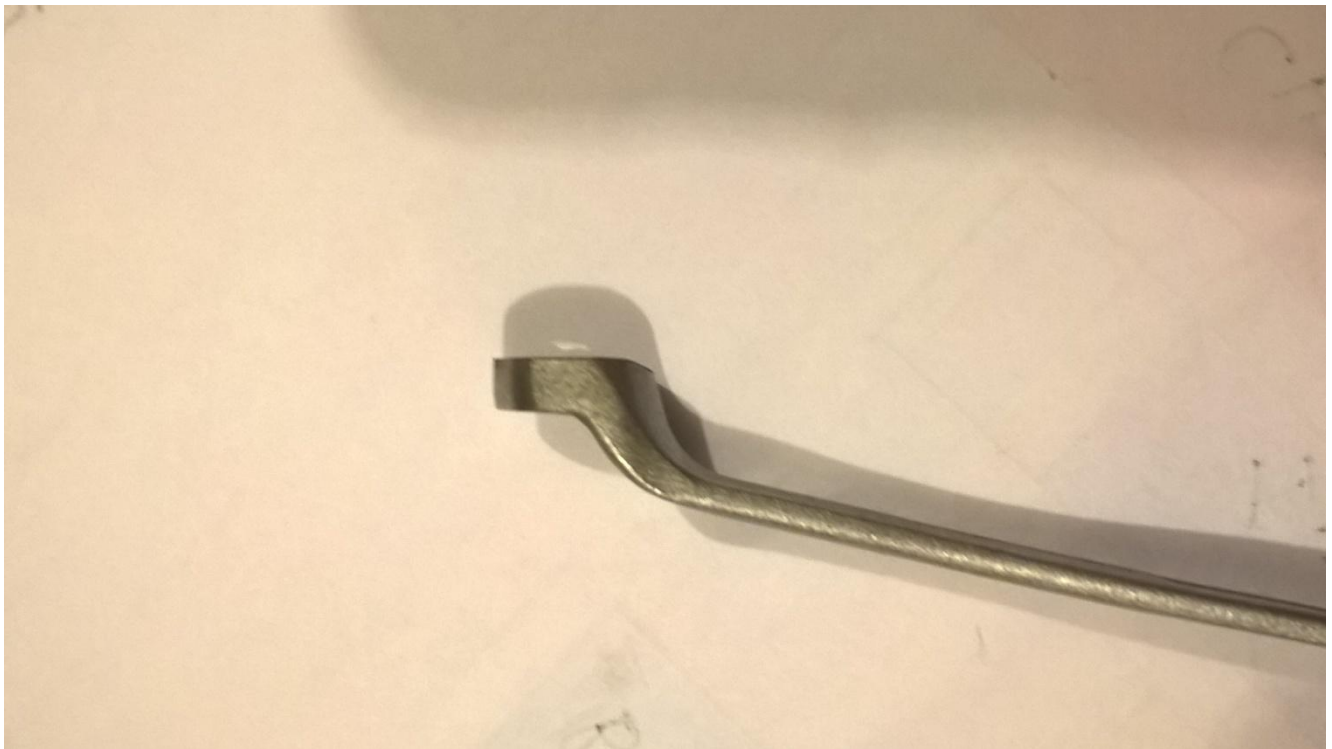
I ground down the shallow off set spanner to 4 mm thick for it to fit between the nut and the sump.

Now tighten both bolts to 12Nm

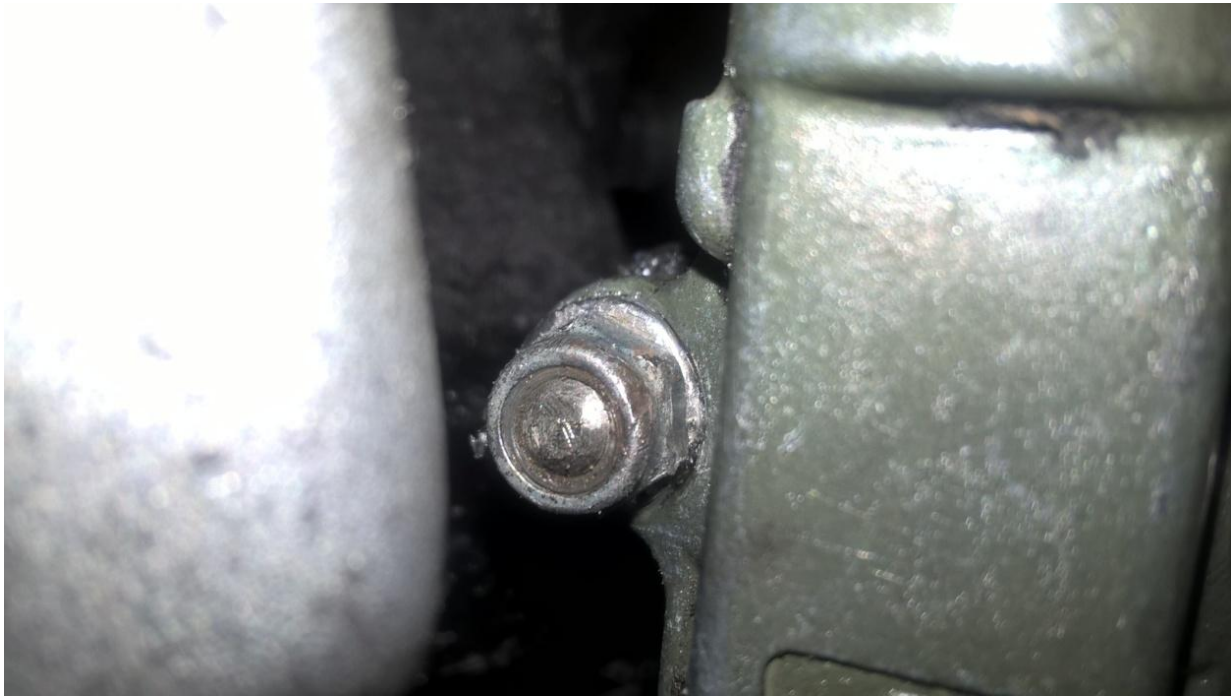
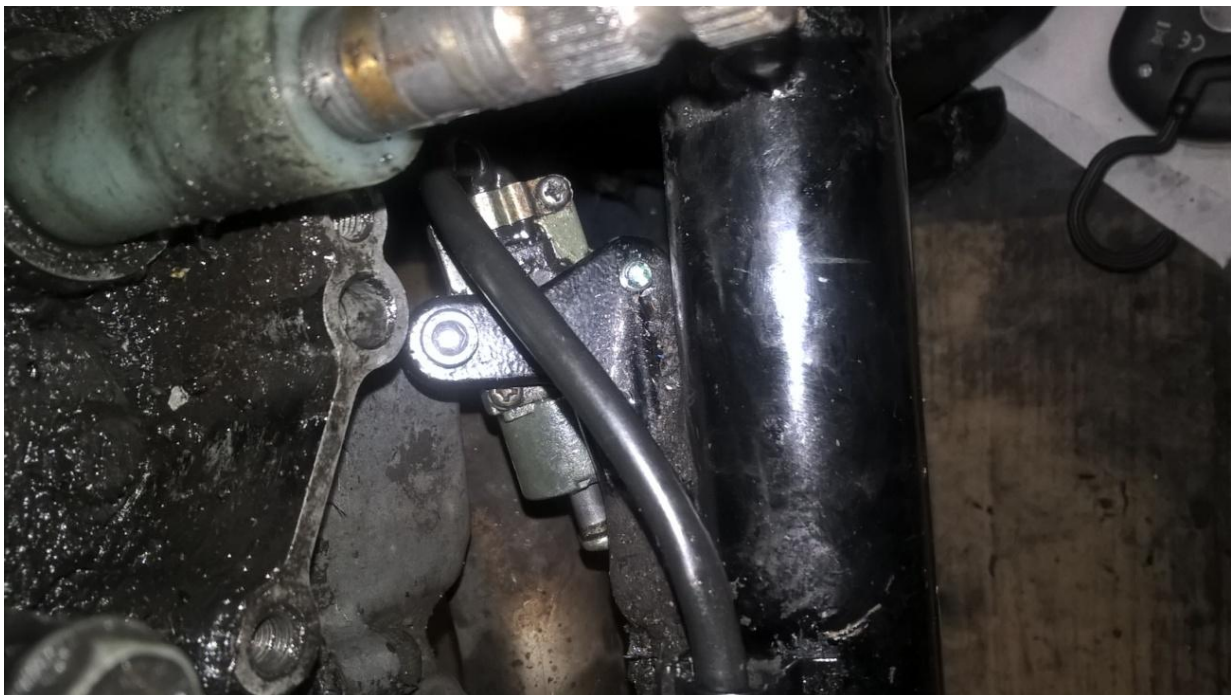
Pictures of completed job

Sorted and now I can remove it if needed again easily.
